MOHAWK RIVER BASIN
TOWN OF GERMAN FLATTS
HERKIMER COUNTY, NEW YORK

**ILION RESERVOIR
NO. 1 DAM
NY 00186**

**PHASE I INSPECTION REPORT
NATIONAL DAM INSPECTION PROGRAM**

JULY 1981

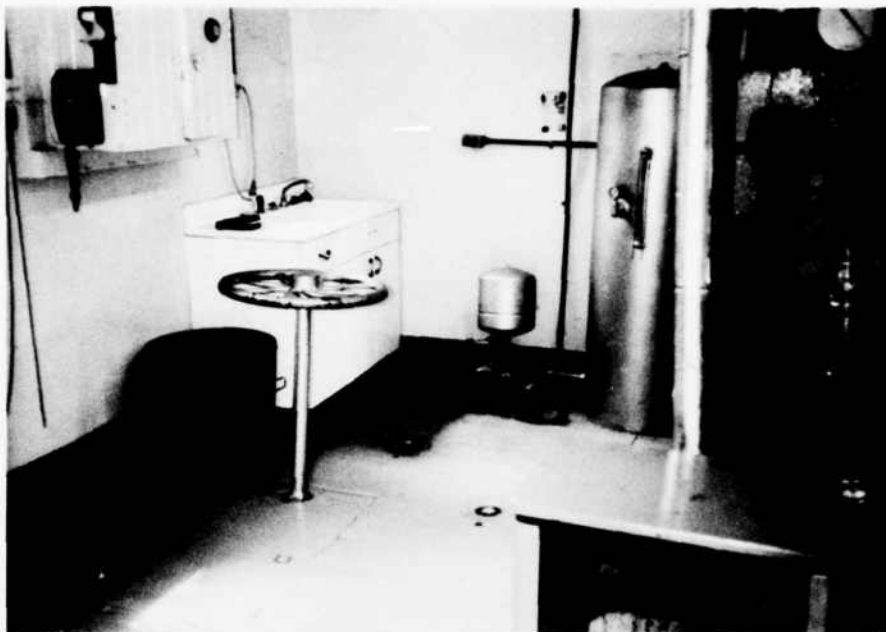
81 on the top floor of the filter plant control building, is used regularly, and is in good condition (see Photo A-8A). The valve and downstream end of the pipe are rusted but still function adequately (see Photos A-8B and A-9A).

A-8A Top level of filter plant control building with removable handwheel and stem on blowoff valve operating nut - 6/4/81

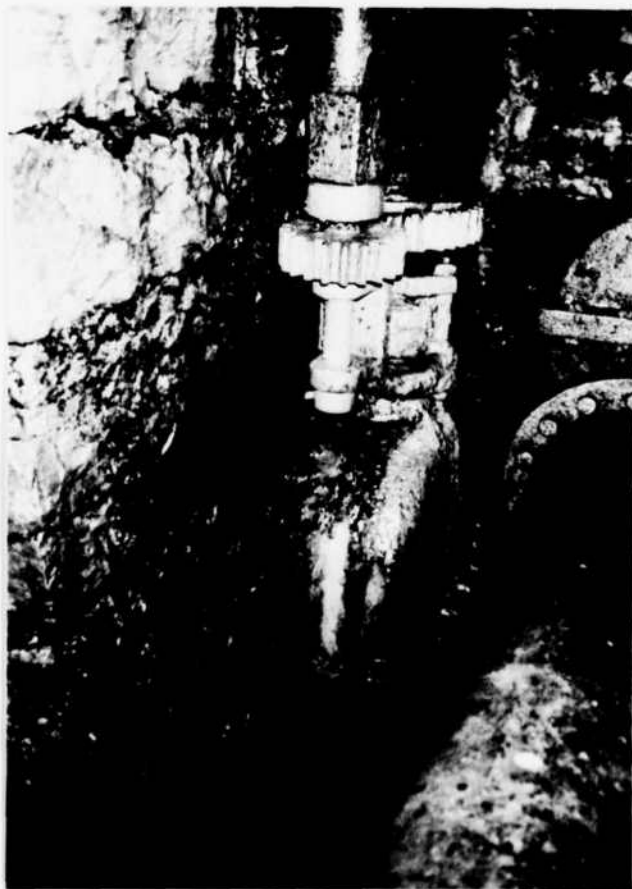
A-8B Blowoff valve in bottom of filter plant control building - 6/4/81
